# Creek Rehabilitation Case Studies

Version 1, 2014

Prepared by: Grant Witheridge, Catchments and Creeks Pty Ltd

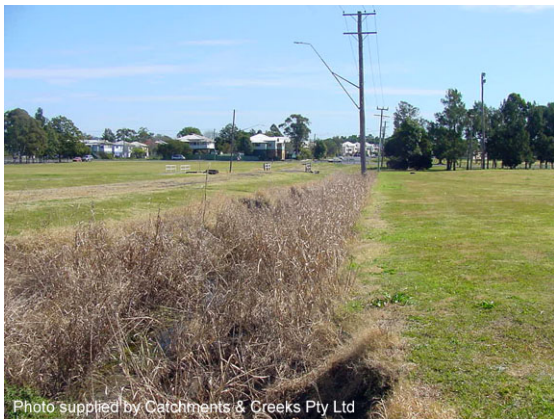
Pre-works site conditions (2003)

- The site was constrained by planned road works south of the drain, and the sports ovals on the northern side of the drain.
- It was also considered desirable to avoid the relocation of the telephone pole.
- The site contains a cracking clay soil that benefits greatly from suitable vegetation cover that can reduce soil drying.
- The visually unattractive, low-value stormwater drain was also subject to urban litter, including shopping trolleys.

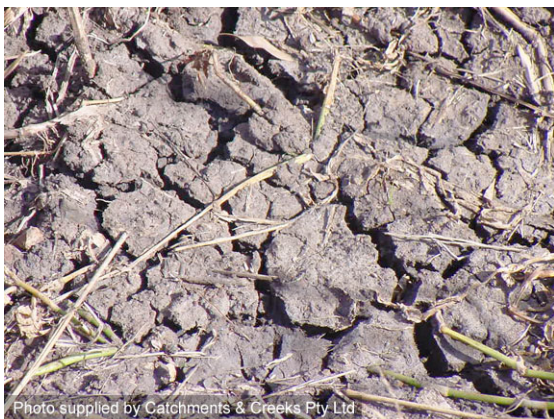
Erodible, cracking black soils

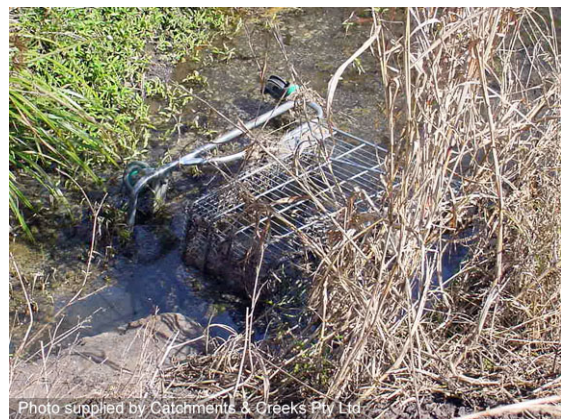
Deposition of rubbish in storm drain

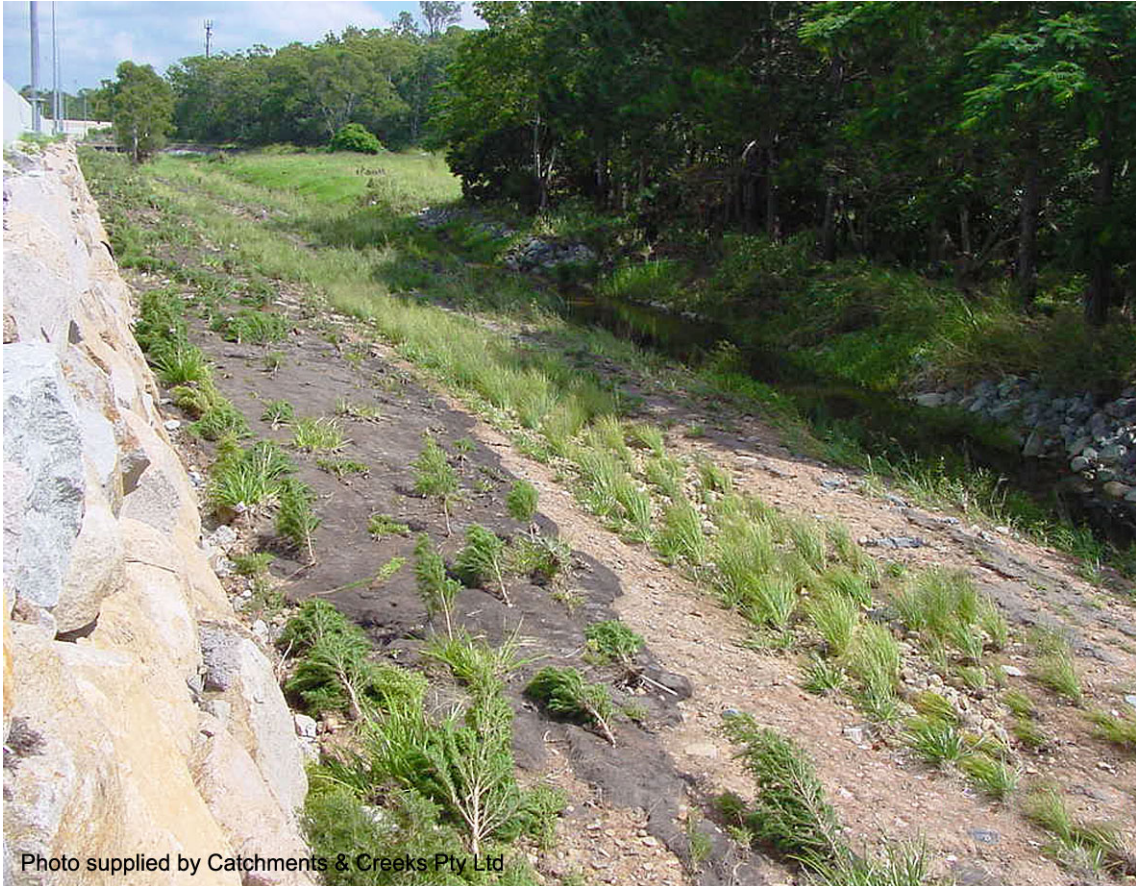
**Looking downstream towards the culvert (after flood damage, 2001)**

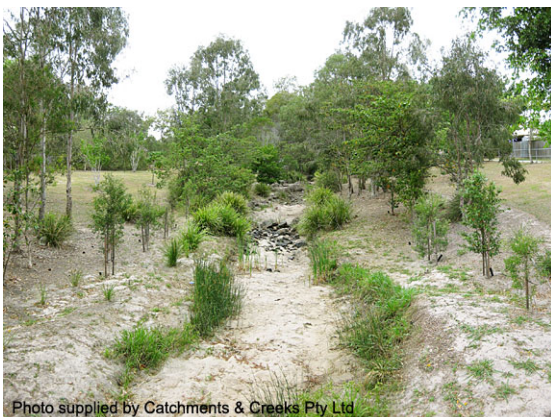
**Upstream of Laurel Oak Dr (Nov, 2014)**

- During the early years, plant establishment was dominated by reeds and weeds within the moist low-flow channel.
- At this stage there is the risk of floods causing bank erosion on either side of the reed-infested low-flow channel.

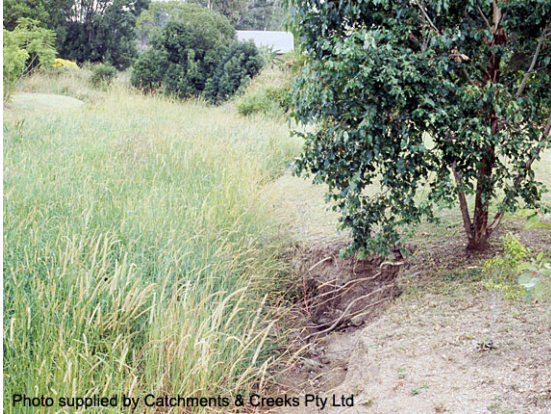
Looking upstream (April, 1996)

- Bank erosion is evident along the northern bank of the creek.
- The bank erosion is worse adjacent the growing shrub due to the increased shading of the bank caused by the presence of the shrub.
- The root system of the shrub cannot control this form of scour erosion.

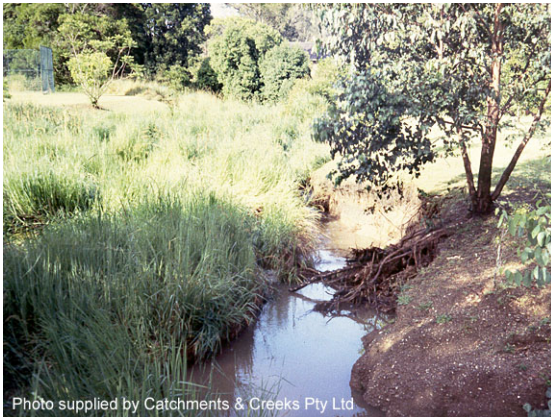
Looking upstream (November, 1996)

- A new low-flow channel is forming along the base of the northern bank as a result of the following factors:
  - weaker bank vegetation along the northern (shaded) bank
  - weed infestation along the creek bed
  - sediment deposition within the channel.
- This image (left) represents the creek condition after the severe May 1996 storms.

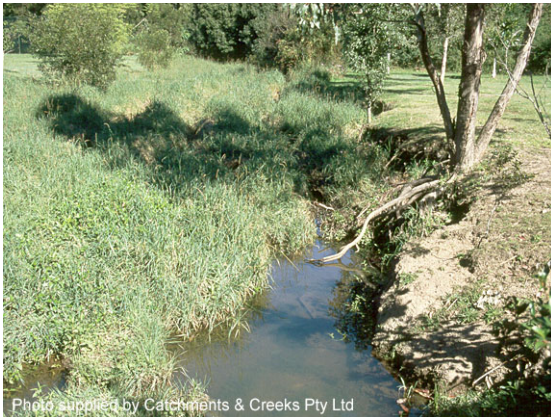
Looking upstream (1999)

- The bank-side shrub is in poor health due to the severe soil loss around its root system and the resulting root damage.
- The fluvial condition being demonstrated here is the accelerated migration of a creek channel to the north caused by the removal of a canopy cover from the creek.

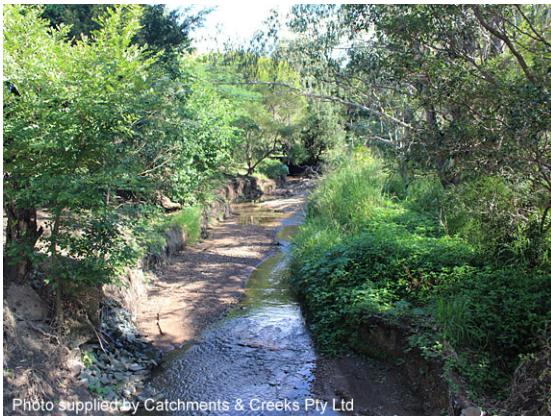
Looking upstream (2011)

- Riparian cover returned to both banks of the creek, which has reduced the density and strength of the in-channel weeds.
- Significant channel flows over the period 2009 to 2011 have caused the previously settled sediment to be displaced resulting in the formation of near-vertical creek banks.
- Subsequent bank erosion can in some cases undermine the newly established bank vegetation.

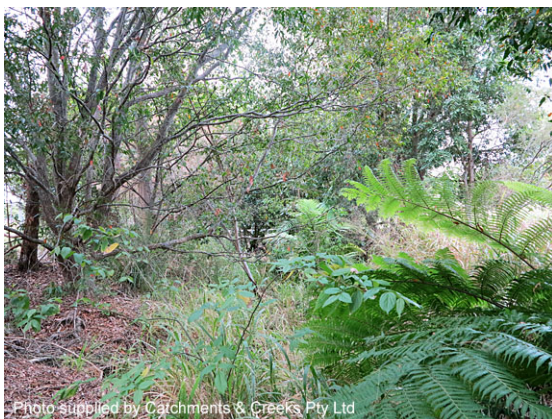
Looking u/s towards footbridge (2014)

- Establishment of a healthy canopy cover has caused significant shading of the channel banks leading to a reduction in the density of ground covers on the channel banks compared to that on the bed.
- In this condition the channel bed is **less** susceptible to erosion than the channel banks.
- Bank erosion can be seen each side of the well-grassed channel bed.

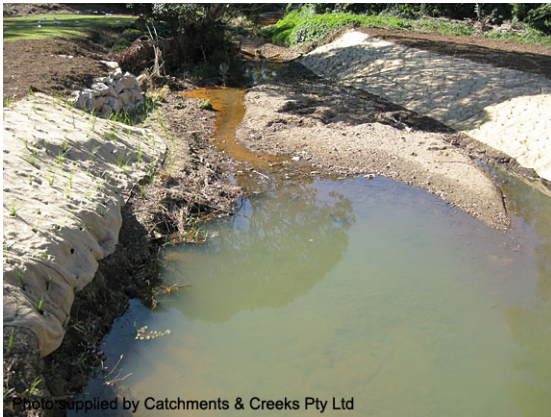
Looking d/s from footbridge (Aug, 2009)

- The reduced channel roughness caused by the upstream weed removal has increased flow velocities within the creek.

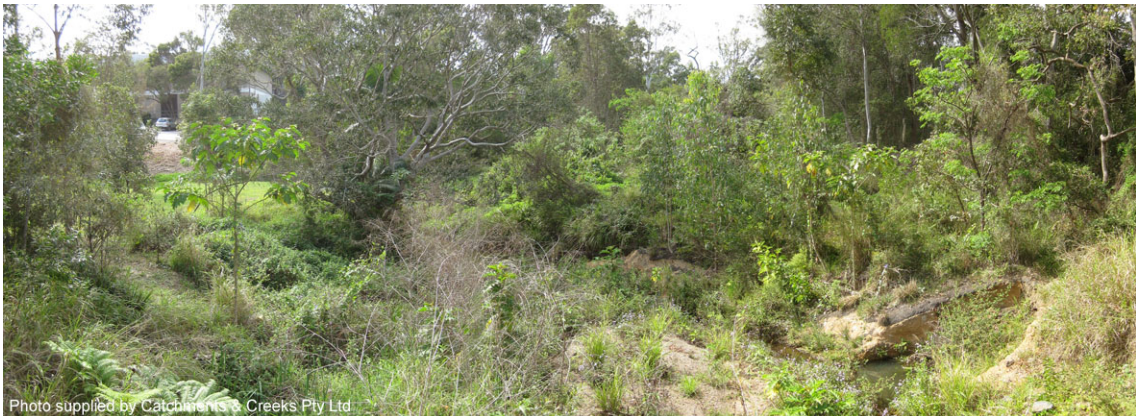
Looking downstream from the Beverley Reserve footbridge (2014)

- As of 2014 the bank erosion had not been repaired; instead the area was left to revegetated naturally.

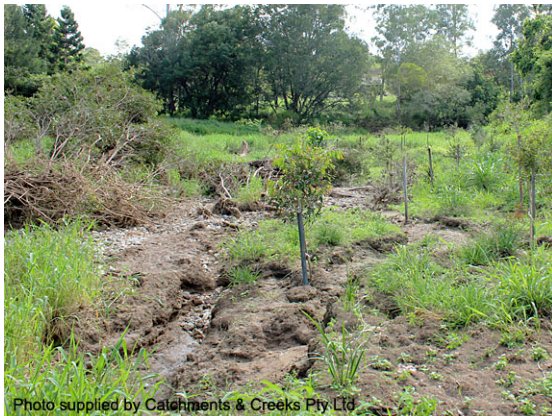
Flood damage (2013)

- Significant as the flood damage was, it was not as devastating as had occurred within other creeks during wet years of 2010 to 2013.
- This site proved the benefit of retaining significant weed cover during the establishment phase of the replacement native plants.
- If complete weed removal had occurred on this site, then the flood damage would have likely been more extensive.

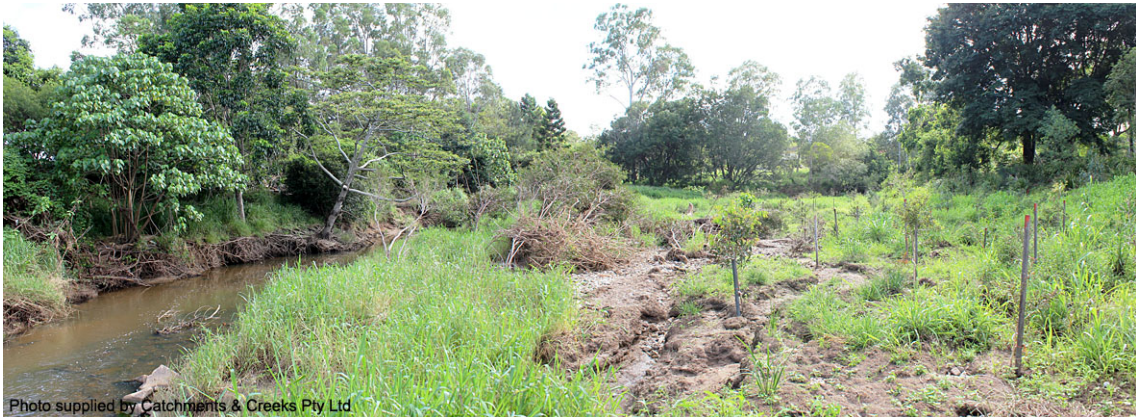
**Looking downstream through the area of greatest flood damage (2013)**
