# Creek Rehabilitation Case Studies

Version 1, 2014

Prepared by: Grant Witheridge, Catchments and Creeks Pty Ltd

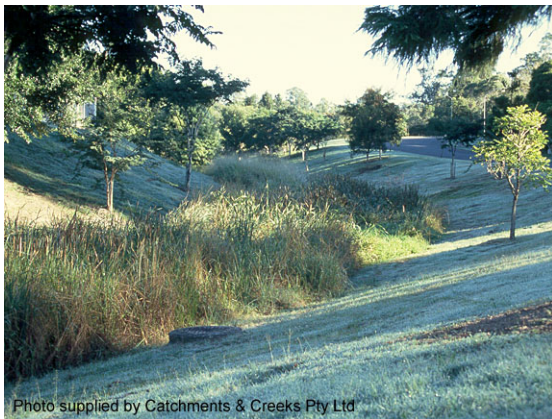
Grassed drain (pre-works, 1999)

- The original purpose of the channel works was to reduce the long-term soil saturation problems experienced by the channel bed.
- Soil saturation made mower access to the far bank difficult, and reduce the potential for the planting of native species.
- The original proposal involved forming a well-defined, 300 mm deep, low-flow channel by raising part of the bed at least 300 mm.
- A habitat pool was also constructed.

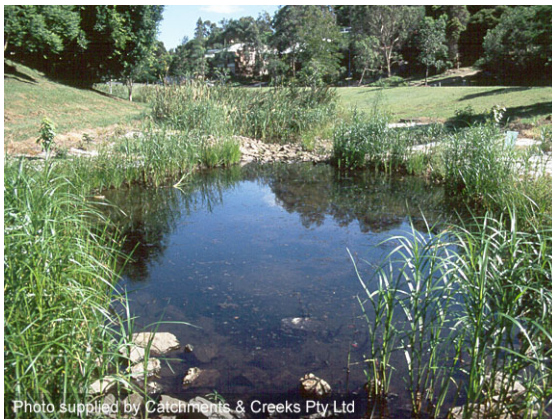
Constructed habitat pool (2000)

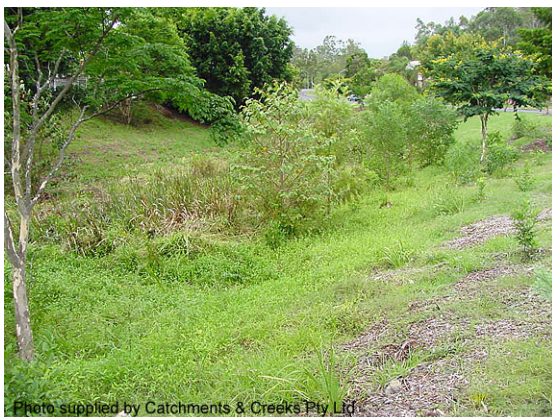
- Unfortunately, cost savings on this low budget project meant that the bed was not raised sufficiently above the low-flow channel—this meant the soil saturation problems continued.
- Also, the upstream reeds and weeds provided a seed source that invaded the habitat pool—this meant that the pool quickly filled with reeds and weeds.
- Ultimately, reed control will only be achieved through the development of a canopy cover.

Reed/weed invasion of pool (2001)

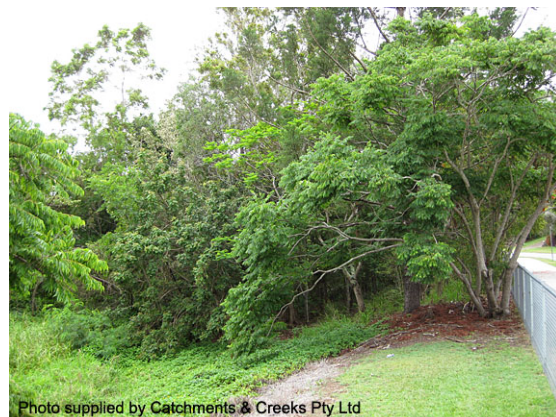
Established canopy cover (2014)

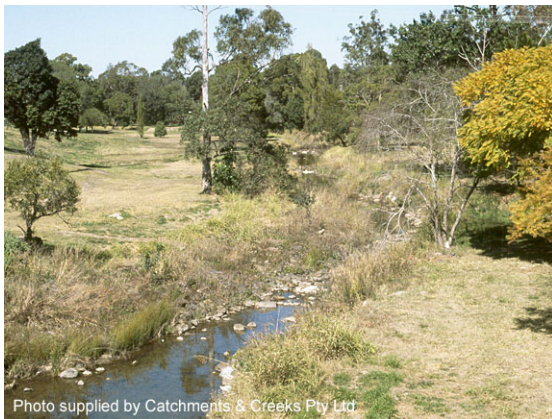
Looking d/s from Moggill Rd (1991)

- In the early 1990s the creek had poor aesthetic appeal due to the exposed, weedy banks.
- Construction waste, in the form of rock, broken concrete and earth, had been used to stabilise and protect the channel banks adjacent the various sewer pipe crossings and sewer inspection chambers (just visible on the right of this image).

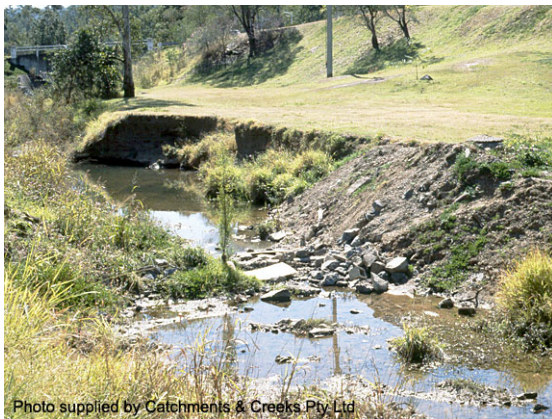
Protection of sewer with rubble (1991)

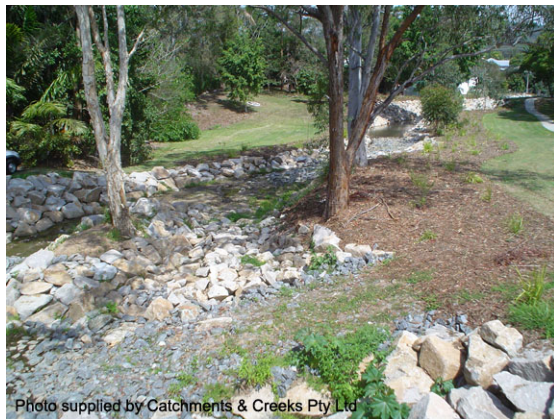
Looking upstream from Samford Rd (2005)

- This project involved the rehabilitation of a park drain back into a waterway.
- Significant quantities of rock stabilisation occurred along the banks of the waterway.
- An existing tree was retained as an 'island' in the middle of the channel.
- Soil was not placed within the rock voids, which delays the establishment of vegetation on the channel banks.

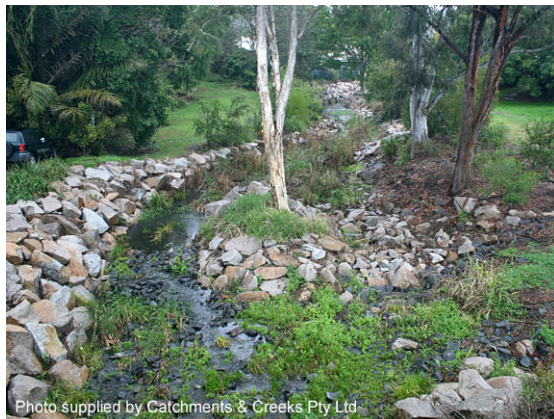
Looking upstream from Samford Rd (2007)

- Plants are beginning to establish on the channel bed, but with only limited plant establishment on the banks.
- A significant drought between 2005 and 2007 had delayed vegetation establishment along the waterway.

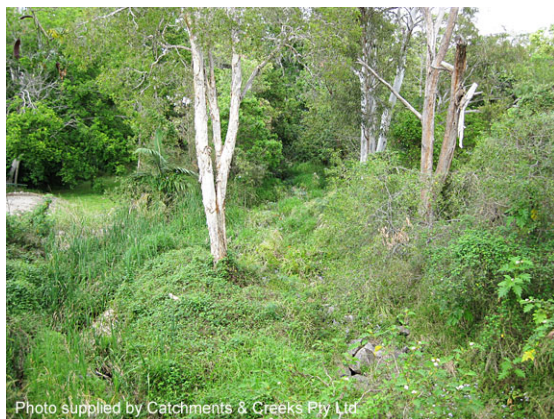
Looking upstream from Samford Rd (2014)

- Significant weed infestation along the channel bed.
- The north-south alignment of the creek, and the open canopy to the north of the creek produced by the existence of Samford Road, means this section of the creek will always experience a weed problem.
- The shading produced by the growing canopy cover should reduce weeds in the upstream section of the creek.

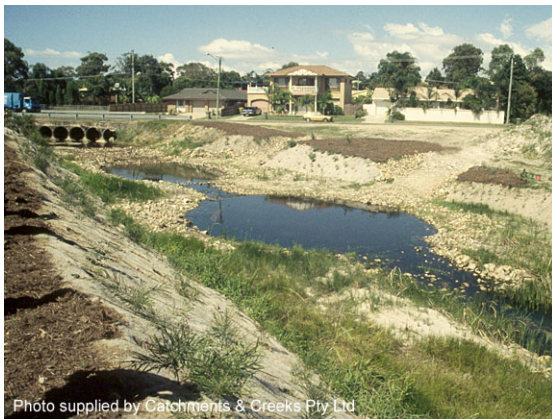
Sediment pond upstream of works (1996)

- Originally presented as a demonstration of *Natural Channel Design* concepts.
- A significant sediment collection pond was established upstream of the channel works.
- The establishment of canopy trees and the resulting shading of the channel has unfortunately not controlled the extensive weed infestation.
- The channel works provide significant terrestrial and aquatic instream habitat.

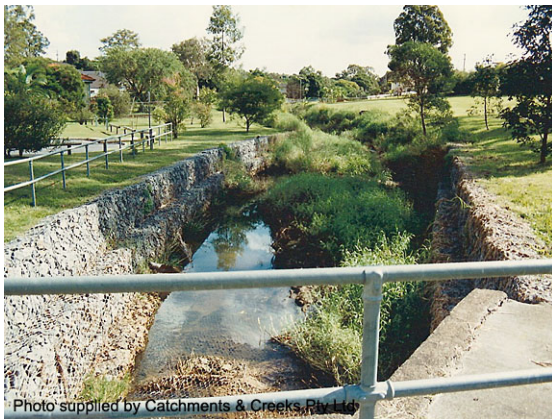
1996

- As was the case for many council parks, riparian vegetation had in the past been removed from the bank and over-bank areas of the creek to improve safety and the park's visual amenity.
- Parts of the creek had been piped to improve public safety and active recreational usage within the park.

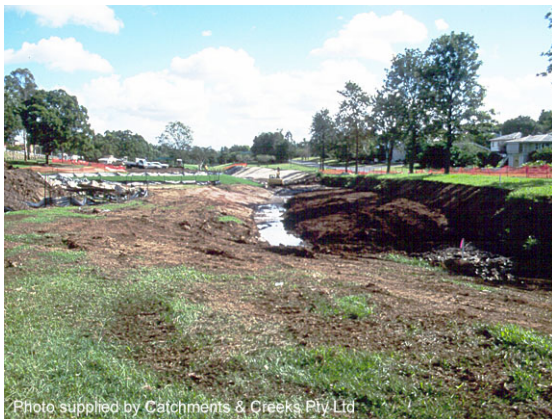
Construction phase, May 2000

- Lobbying by the Norman Creek Catchment Coordinating Committee (N4C) resulted in the proposal for creek rehabilitation through the park.
- Channel rehabilitation commenced in 2000.
- The project involved significant bank stabilisation with rock and the stabilisation of the creek bed with rock weirs.

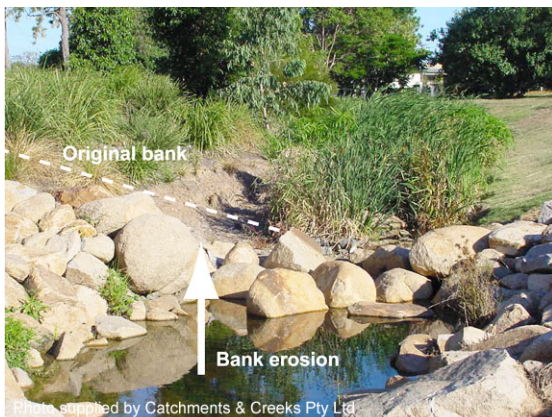
Bank erosion adjacent rock riffle (2002)

- Significant bank erosion occurred in locations where rock was not placed along the toe of the revegetated banks.
- This toe erosion (left) was primarily caused by the rapid growth of bed vegetation (reeds) which gained strength faster than the newly established bank vegetation.
- The establishment of reeds along the creek bed can cause significant problems in the early stages of creek rehabilitation.

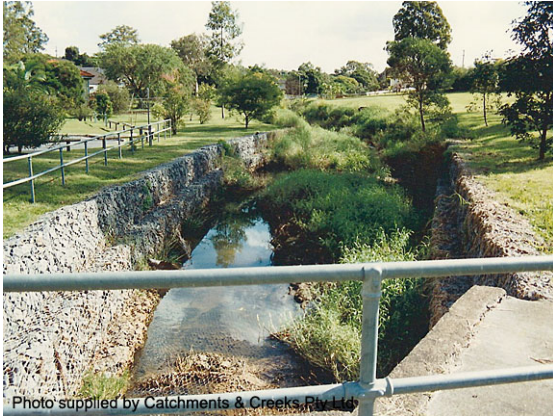
Looking downstream from outlet (1996)

- In the 1990's, the creek presented itself more like a grass-lined drainage channel.

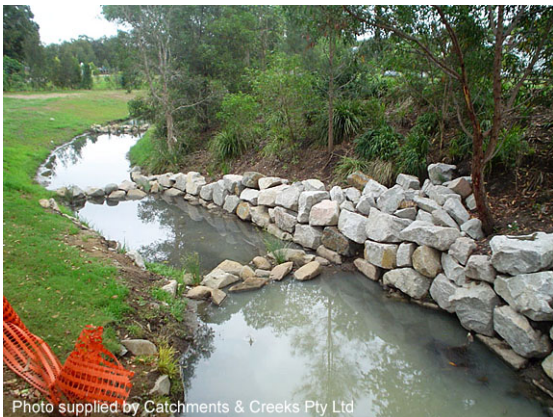
Looking downstream from outlet (2005)

- As was typical at this time, plants were not initially established within the rock voids.
- The rock weirs placed along the creek bed differ from rock riffles in their shape and hydraulic operation.

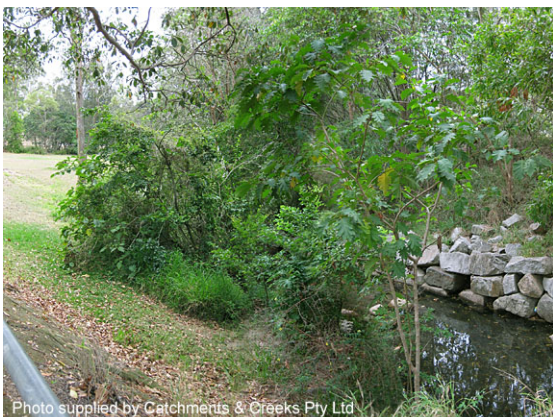
Looking downstream from outlet (2014)

- Riparian vegetation is well advanced along the eastern bank, but the canopy cover is not fully established.
- Some of the rock weirs have been damaged by flood flows.

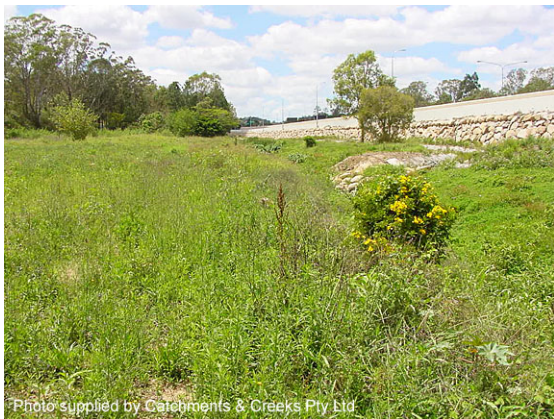
Looking downstream from culvert (2000)

- Riparian vegetation was largely cleared along the creek to provide flood mitigation.
- In the 1990s Norman Creek in this area resembled little more than an open storm drain passing through a grassed field.

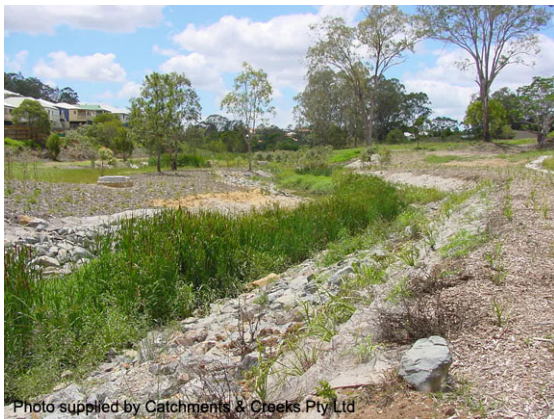
Upstream reach (2001)

- Construction of the busway adjacent to the South East Freeway resulted in the first stage of creek rehabilitation.

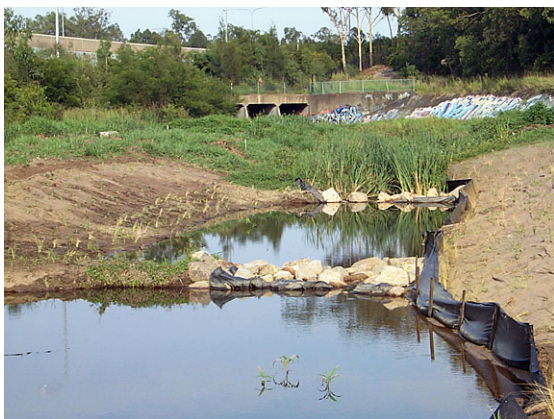
Looking downstream to culvert (2001)

- Lobbying by the Norman Creek Catchment Coordinating Committee (N4C) resulted in the proposal for more substantial creek rehabilitation.
- A series of pools and riffles were formed along the creek based on the past success of a similar creek rehabilitation project adjacent to Willis St, Tarragindi (Ekibin).

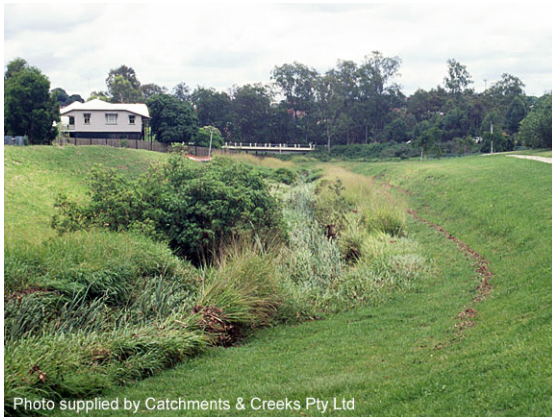
Old channel looking to Arnwood St

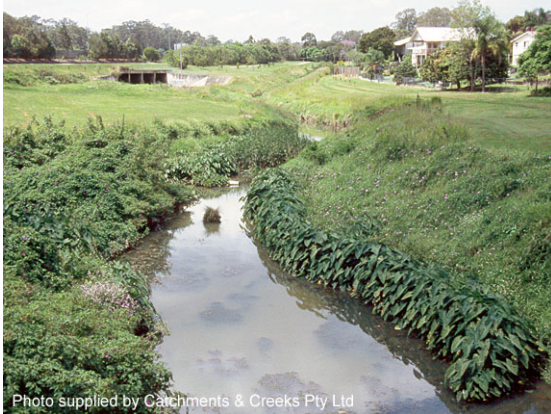
**Looking upstream from bridge (1999)**

- Pre-works site conditions.
- Creek channel has significant weed infestation

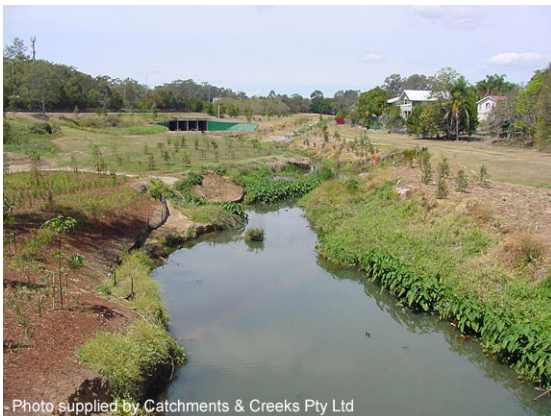
**Following first stage of works (2001)**

- Post works condition.
- Pools and riffles established with some planting within over-bank areas.
- Creek is nutrient-rich with heavy algae growth.

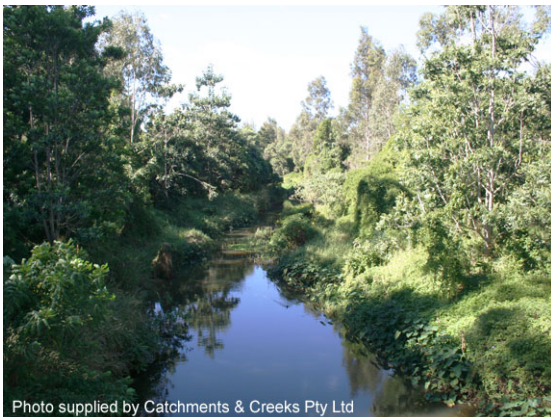
**Looking upstream from bridge (2010)**

- Canopy trees have achieved significant height, but not full maturity.
- Significant weed cover exists within the understorey.
- Tree establishment along the northern bank (visible to the left) is now beginning to shade the waterway.

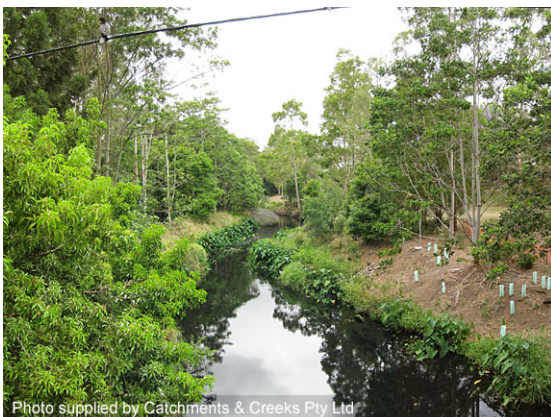
**Looking upstream from bridge (2014)**

- Weeding and partial removal of grass cover within the riparian zone by the local community group.
- Shading from the established canopy cover also helps to thin the understorey and groundcover plants.
- The creek had experienced significant flood flows during 2009, 2010 and 2011.

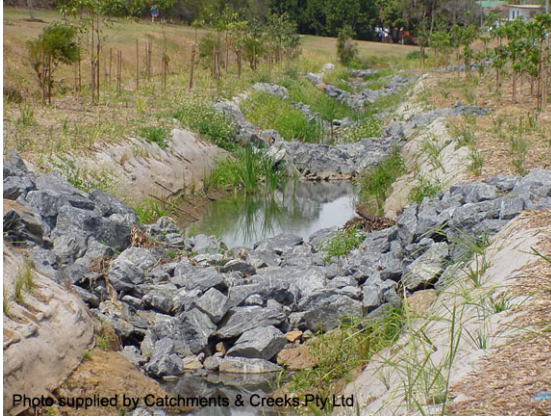
**Constructed pool-riffle system (2001)**

- Pool-riffle systems are not natural in all waterways, and thus should not be considered an essential element of all creek rehabilitation projects.
- In this case the riffles help to control channel erosion that would otherwise have occurred once the canopy cover began to shade-out the grass cover.
- The use of 'blue' quarry rock may not be ideal, but the rocks usually develop a more natural brown/green colour over time (see below).

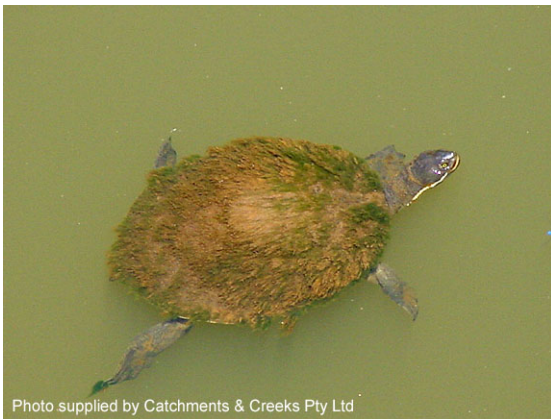
**Nutrient-rich waters (2001)**

- This image of an algae encrusted turtle was taken within the deep pool that exists upstream of the Arnwood Place bridge in 2001 just after the completion of the channel works.
- This algae problem contributes to a reduction in dissolved oxygen within the water.
- Improved shading of the water body and improved stormwater practices within the catchment should see a reduction in this algae problem.

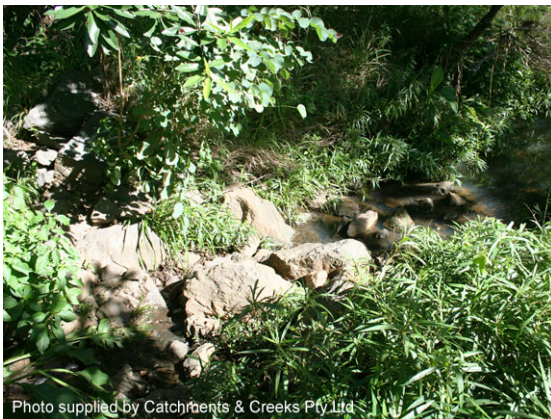
**Downstream riffle (2010)**

- The location of the downstream riffle has been adopted by locals as a stream crossing point.
- The riffle rocks substitute as stepping stones for the stream crossing.

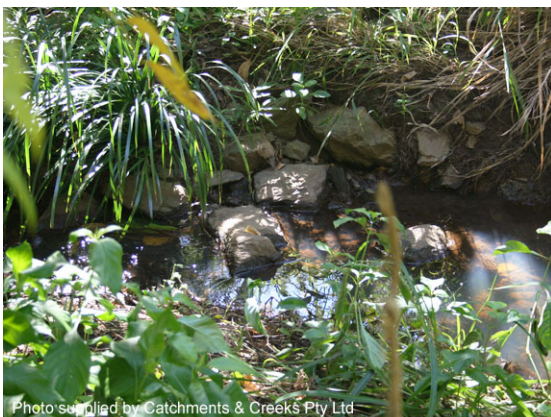
**Upstream riffle (2010)**

- The riffles have established desirable flow conditions that would encourage fish passage up the waterway.

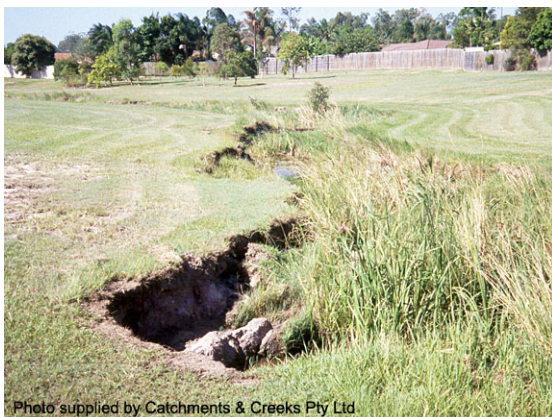
Channel erosion (1998)

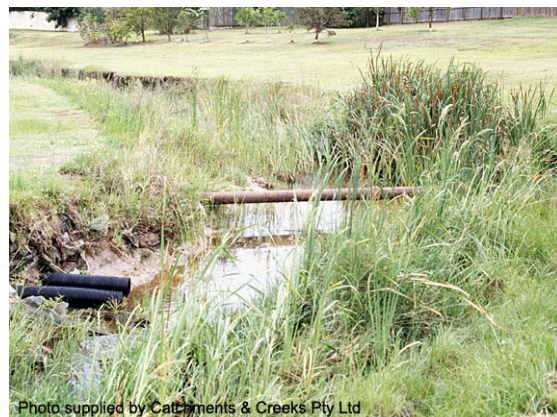
Exposed Ag-pipe & sewer crossing (1997)

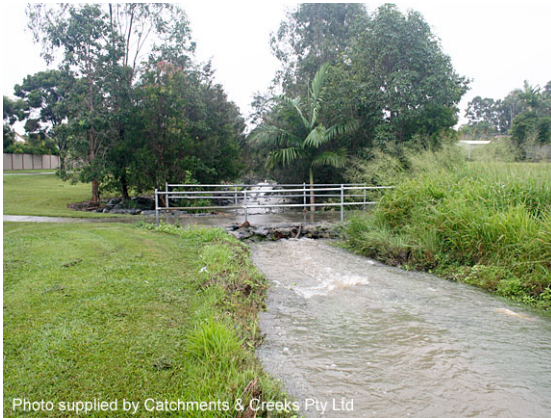
Looking d/s to the footbridge (2010)

- Due to the steep gradient of the creek, and local flood control issues, the decision was made to retain the existing (1998) alignment of the low-flow channel.
- It was also agreed with the council that the footbridge would remain in its current location.

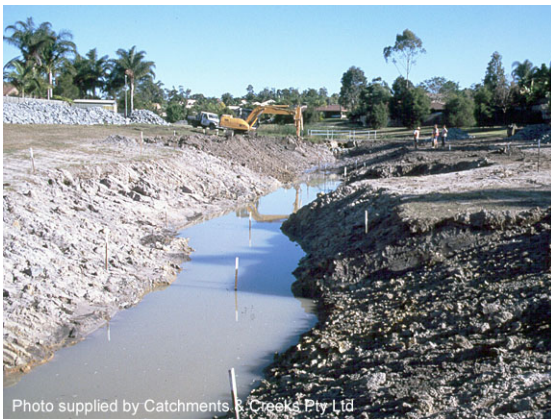
Looking upstream to footbridge (1999)

- Significant quantities of rubbish (burnt tree stumps) and highly erodible slaking soils were found in the stream banks adjacent the low-flow channel, which resulted in the need for this material to be removed.
- The channel was then lined with stable soil and a rock-lined pool-riffle system was constructed.

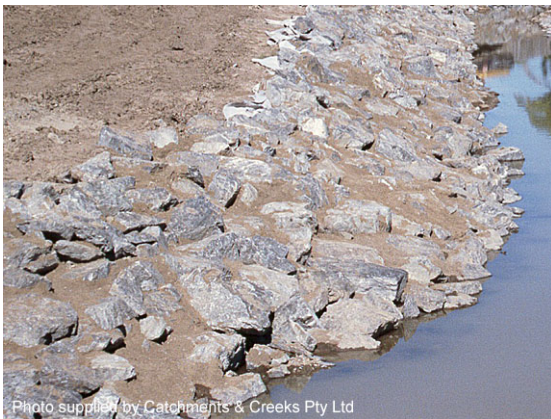
Soil-filled voids ready for planting (1999)

- This project was one of the first examples in Brisbane where the voids between the rocks were filled with soil allowing plants to be introduced into the channel upon completion of the channel works.
- Prior to this, the practice of filling the voids with soils was considered unacceptable due to the risk of the soil being washed from the rocks by stream flows.
- Even though some soil is lost, the benefits gained through the earlier establishment of vegetation are significant.

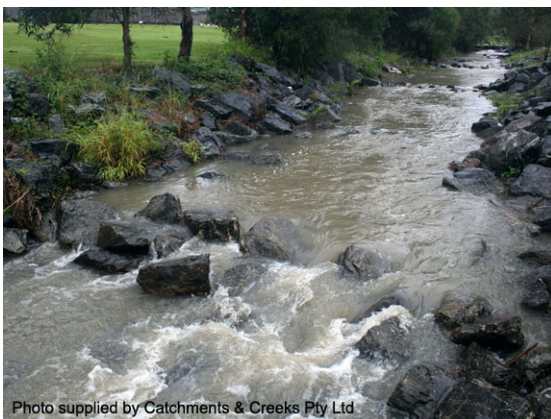
Pool-riffle system (2010)

- The channel falls in elevation only 400 mm at each riffle system, which is approximately the size of the rocks.
- When initially constructed (see photos over page) the individual pools and riffles were not clearly distinguishable amongst all the other bank stabilisation rock.
- Establishment of a canopy cover, which helps to control weeds, allows the pool-riffle system to be more clearly identifiable.

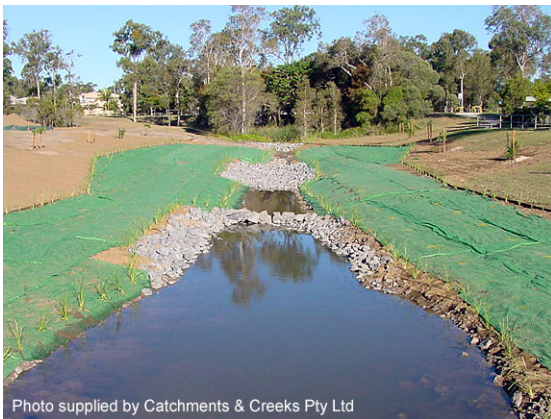
**Upstream of Laurel Oak Dr (2001)**

- Stage 2 of the project consisted of similar channel works being constructed between Nottingham Road and Laurel Oak Drive.
- The lower channel gradient allowed the use of erosion control mats on the battered banks as opposed to rock stabilisation.
- The Laurel Oak Driver culvert was also modified to reduce sediment and debris blockage problems.

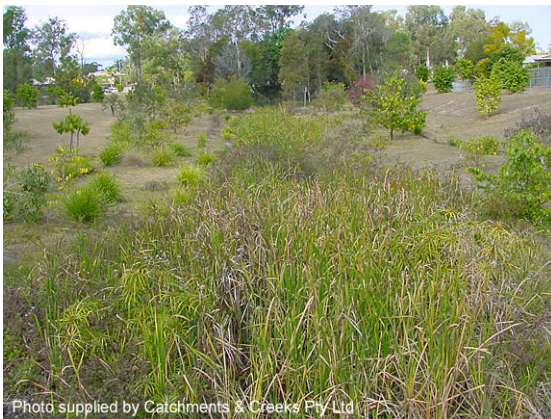
**Upstream of Laurel Oak Dr (2004)**

- During the early years, plant establishment was dominated by reeds and weeds within the moist low-flow channel.
- At this stage there is the risk of floods causing bank erosion on either side of the reed-infested low-flow channel.

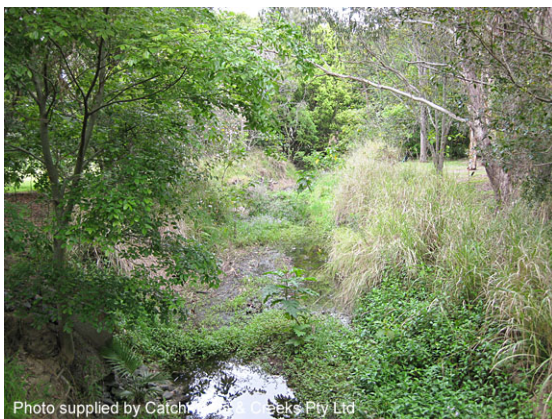
Looking upstream (2014)

- Riparian cover returned to both banks of the creek, which has reduced the density and strength of the in-channel weeds.
- Significant channel flows over the period 2009 to 2011 have caused the previously settled sediment to be displaced resulting in the formation of near-vertical creek banks.
- Subsequent bank erosion can in some cases undermine the newly established bank vegetation.

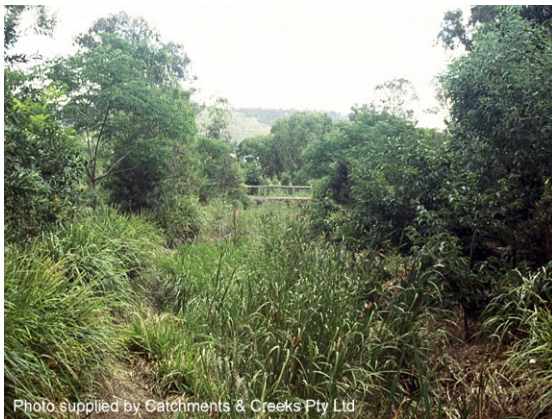
Looking u/s towards footbridge (1998)

- Planted riparian zones were established along both sides of this constructed stormwater drain that passed through the park.
- No works were conducted within the bed of the stormwater drain.

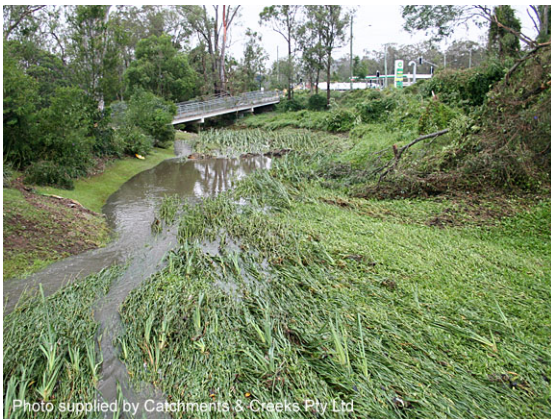
Downstream of Ferry Way (Nov, 2008)

- Significant weed and vine infestation had occurred along both banks of the creek downstream of the Ferry Way culvert.

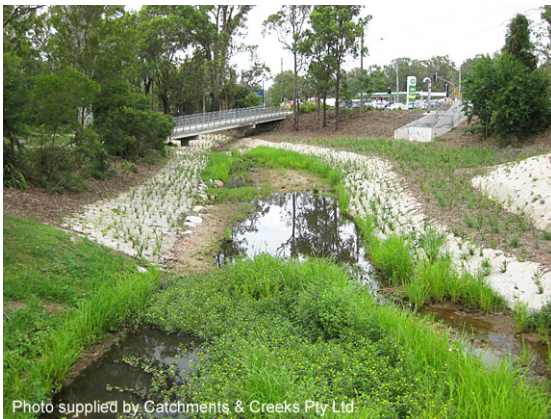
Downstream of Ferry Way (Nov, 2009)

- A comprehensive weed removal and creek revegetation program commenced during the 'dry season' of 2009.

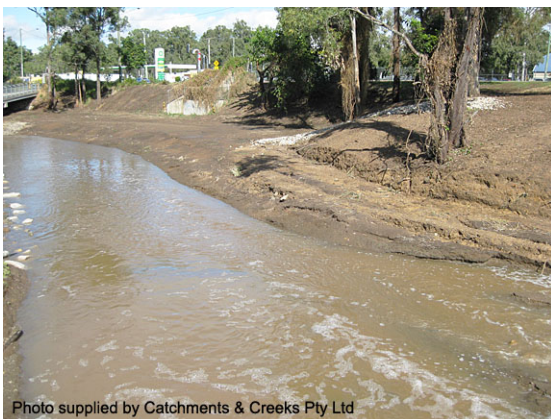
Downstream of Ferry Way (May, 2009)

- The local council followed appropriate procedures and commenced the channel works during the recognised 'dry' season.
- Unfortunately for the project, an unseasonal storm occurred in May 2009.
- This storm caused significant bank and bed erosion within the work area.

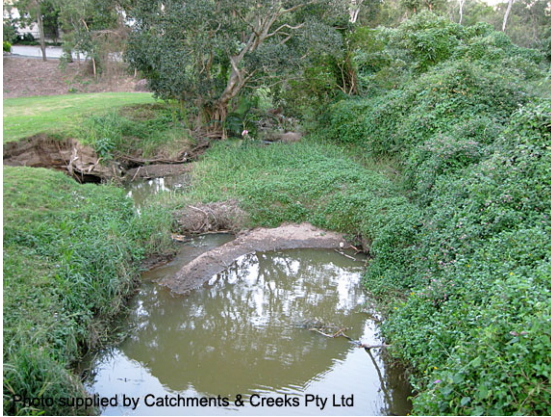
Looking d/s from footbridge (April, 2009)

- This image presents the creek conditions downstream of the footbridge during the period that the weed removal was occurring.
- Following weed removal, this region was stabilised with plants and erosion control mats, but no enhanced toe protection.

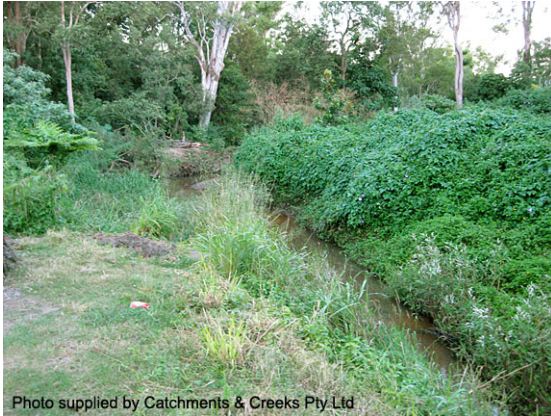
**Downstream of park (April, 2009)**

- Channel conditions downstream of the work area prior to the commencement of week removal.

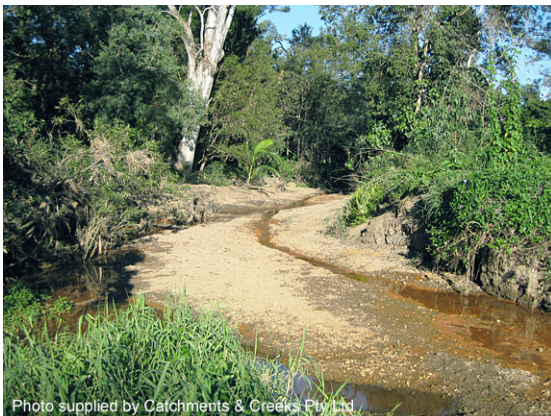
**Downstream of park (Aug, 2009)**

- Sediment removal from the upstream work area resulted in significant sediment deposition within this downstream reach.

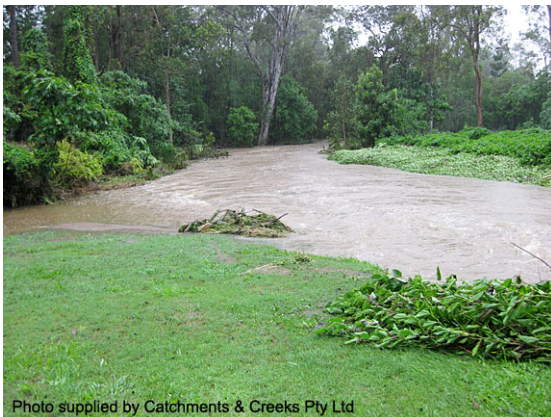
**Downstream of park (Oct, 2010)**

- Significant bankful channel flows occurred throughout 2009 to 2013.

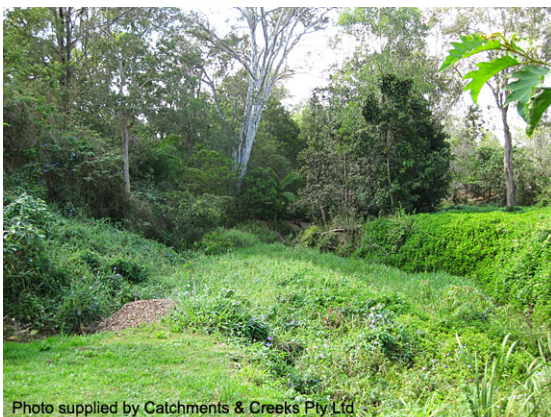
**Downstream of park (2014)**

- Without a substantial canopy cover, weeds have invaded and stabilised the deposited bed sediment.
- Bank erosion is likely to occur as a result of the growth of bed weeds.

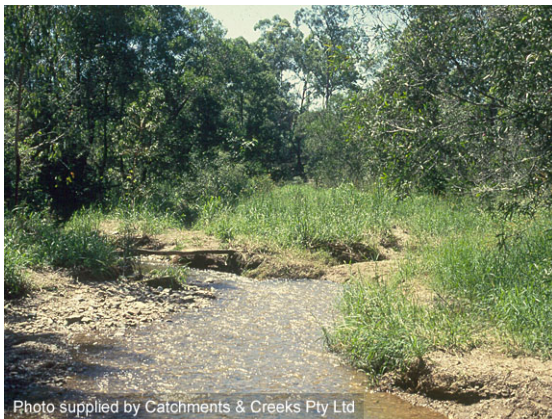
Looking d/s at sediment deposit (1994)

- This reach of Kedron Brook represents the upper most extent of urban development within the drainage catchment.
- Upstream of this reach the creek primarily consists of a rocky pool-riffle system.
- In the early 1990s a residential subdivision adjacent to Lanita Avenue resulted in significant sediment deposition within the creek.

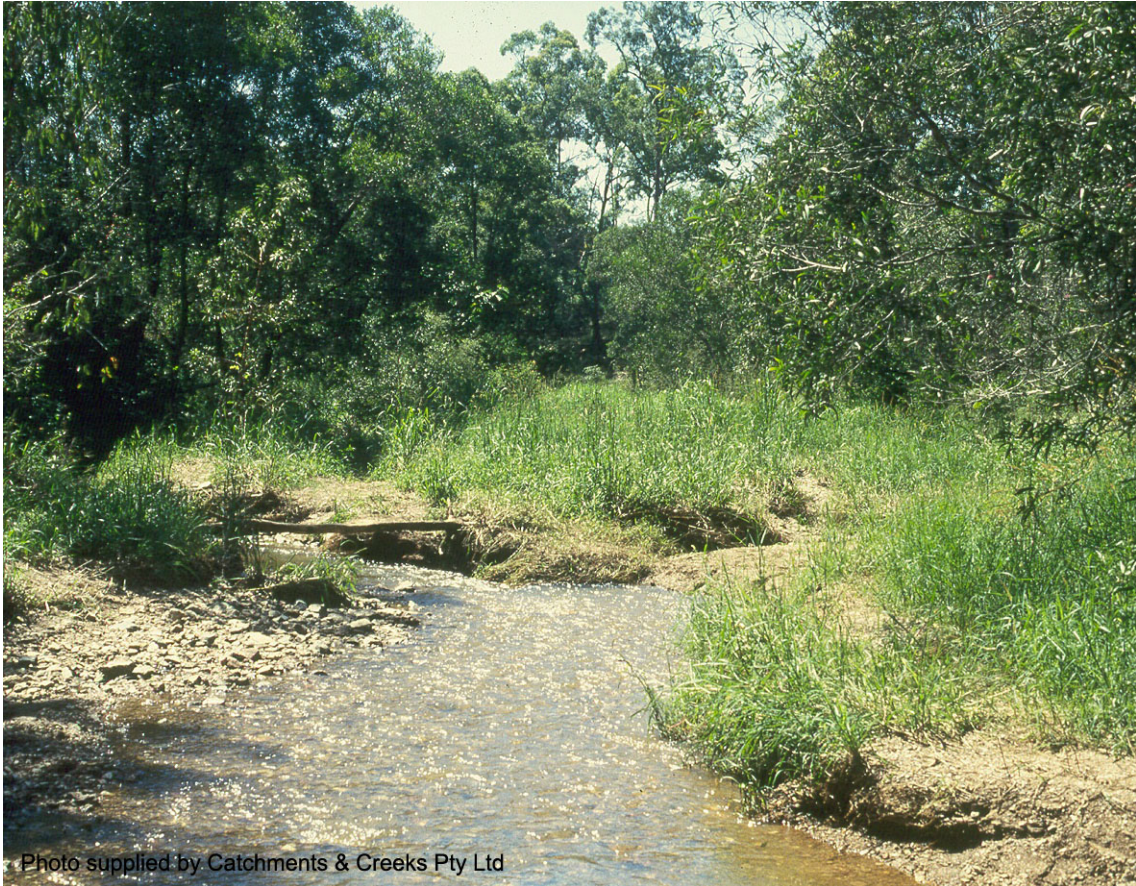
**Looking downstream to sediment deposit adjacent Falconglen Close, Ferny Grove (1994)**
