# Watercourse Erosion – Part 1

## EROSION TYPES AND THEIR CAUSES

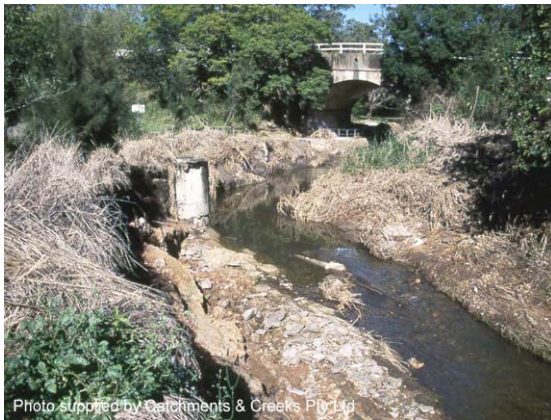
**Photo 1 – Bank scour (Qld)**

Bank scour is the removal of material from the surface of the creek bank as a direct result of stream flow. The erosion may be the result of excessive turbulence (Photo 1), or high flow velocity, such as on the outside of a channel bend (Photo 2).

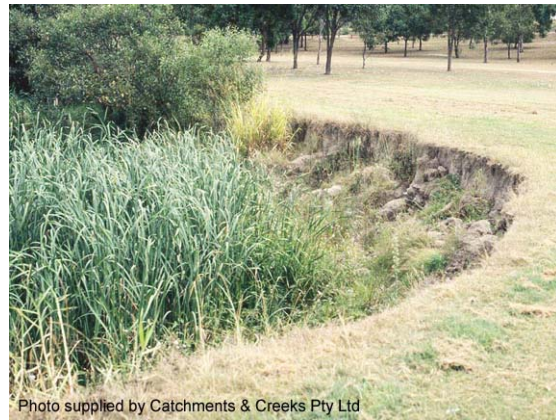
**Photo 2 – Bank scour around the outside of a channel bend (Qld)**

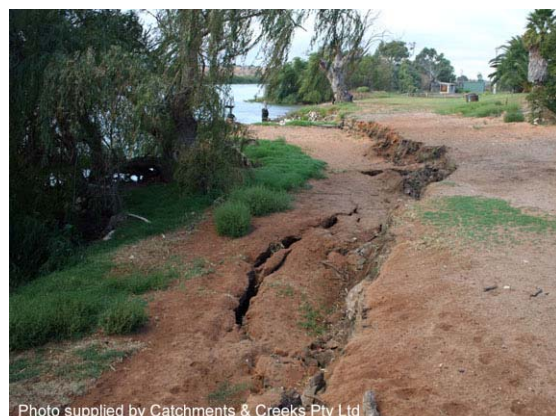
**Photo 3 – Bank slumping (SA)**

Causes include: the removal of trees from the top of the bank, deepening of the channel by erosion or dredging, an unusual or rapid lowering of flood waters following saturation of the banks, or excessive fill material placed on or near the top of bank.

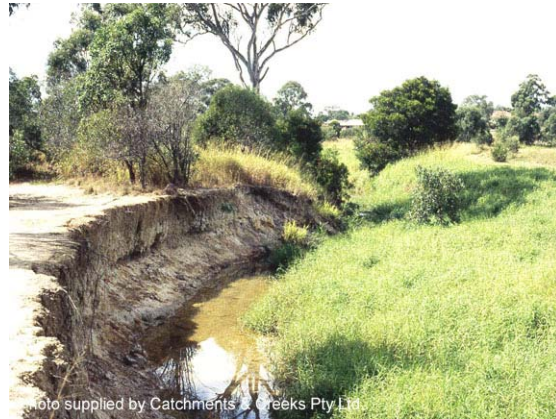
**Photo 4 – Bank undercutting (Qld)**

Bank undercutting is the removal of material from the lower portion of a channel bank by 'bank scour'. This erosion results in the creation of an overhanging bank that usually fails in a more violent motion than occurs in 'bank slumping'. In effect, bank undercutting is a combination of bank scour within the lower bank, which ultimately causes upper bank slumping. The two actions may not occur simultaneously.

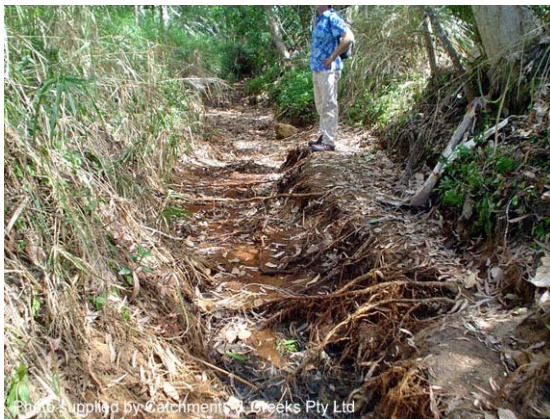
**Photo 5 – Bed scour (Qld)**

Bed scour is the direct removal of material from the bed of the creek either by high velocity flows (causing uniform scour along the bed, Photo 5), or the formation of a head cut (waterfall) that migrates up the creek (Photo 6).

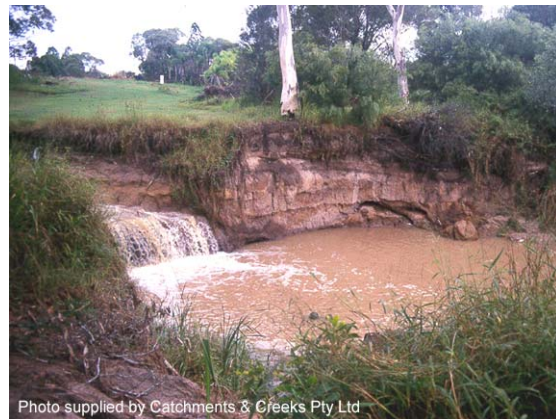
**Photo 6 – Head-cut erosion (Qld)**

- (i) Look for the formation of an unnatural waterfall in the bed of the creek. In small creeks and drainage channels these waterfalls often take the form of a 'bell-shaped' scour hole. This form of erosion usually identifies head-cut erosion and is a clear indication of an unstable channel bed. The cause can be either a change in catchment hydrology, or a change in the downstream channel conditions, such as caused by the clearing of in-bank vegetation, lowering of downstream flood levels, or the construction of a downstream culvert with an unstable drop inlet.

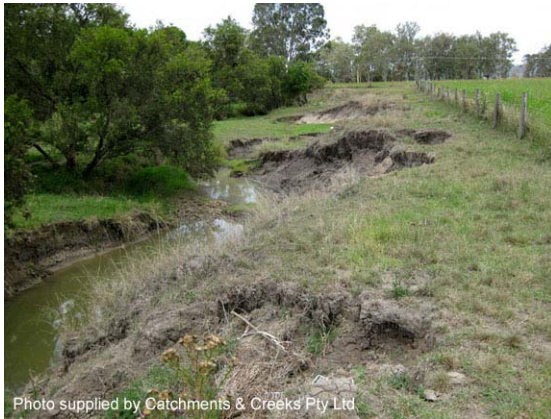
**Photo 7 – Lateral bank erosion (Qld)**

Lateral bank erosion is the erosion of the creek bank resulting from the entry of lateral inflows (usually stormwater) into the creek. The erosion usually takes the form of an upstream progressing erosion head (head-cut) that propagates laterally from the main channel forming a new gully (Photo 8).

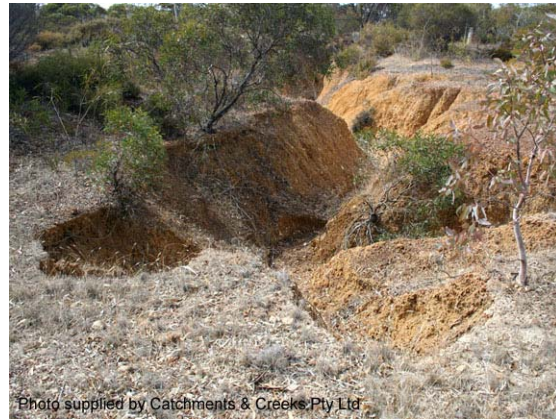
**Photo 8 – Lateral bank erosion (SA)**

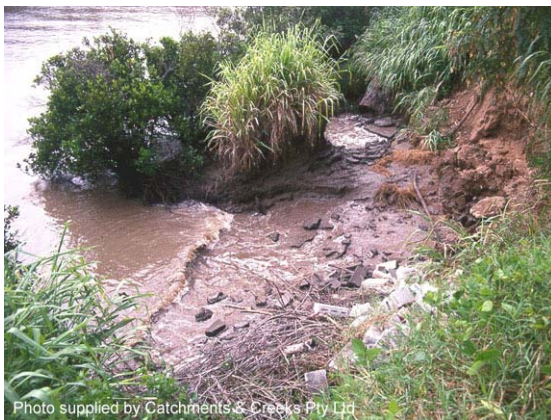
**Photo 9 – Wave induced erosion (Qld)**

Fretting is the direct removal of erosion prone material from the bank of a creek by wave action (Photo 9). This erosion results in the undercutting (Photo 10) and possible failure of the bank.

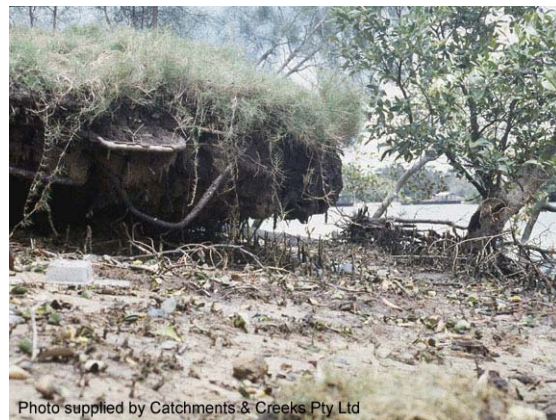
**Photo 10 – Fretting erosion (Qld)**
